Pentium® III Xeon™ Processor Specification Update

Release Date: December 1999

Order Number: 244460-009

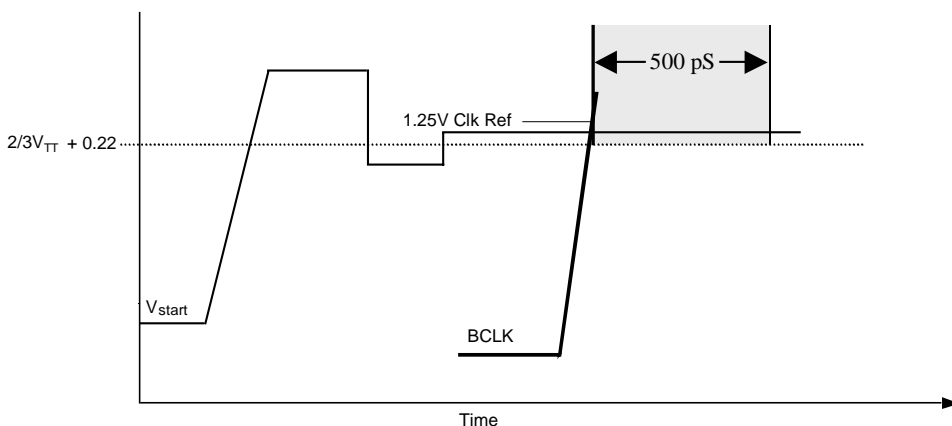
The published AGTL+ AC specification for $V_{IH(MIN)}$ is $(2/3 \cdot V_{TT}) + 0.1$ Volts.

Intel has characterized the new AGTL+ AC specification for $V_{IH(MIN)}$ on the processor's RS0# signal to be: $(2/3 \cdot V_{TT}) + 0.22$ Volts within 500 picoseconds following the rising edge of BCLK crossing the 1.25-Volt threshold. See below.

Implication: The deviation from the published specification results in decreased noise margin on the RS0# processor input. This decreased noise margin has been observed to be particularly detrimental in system environments where the RS0# processor input is being driven by an I/O buffer with a pull-up device (such as a p-channel transistor) that is switched off mid-cycle. Systems which employ I/O buffers that keep the pull-up device on for the entire cycle are significantly less affected by this erratum. The reduction in noise margin may lead to the generation of BINIT# (when enabled) resulting in a system reset, otherwise this condition may lead to a system "hang" condition.

Workaround: If a system design cannot meet the specification deviation, the following areas should be carefully examined to assure that additional margin exists in order to compensate for any deficit observed with respect to the newly characterized $V_{IH(MIN)}$ specification:
